Studies of $\text{YBa}_2\text{Cu}_3\text{O}_{6+x}$ degradation and surface conductivity properties by Scanning Spreading Resistance Microscopy

Local surface conductivity properties and surface degradation of c-axis oriented $\text{YBa}_2\text{Cu}_3\text{O}_{6+x}$ (YBCO) thin films were studied by Scanning Spreading Resistance Microscopy (SSRM). For the surface degradation studies, the YBCO surface was cleaned by ion beam etching and the SSRM surface conductivity map has been subsequently repeatedly measured over several hours in air and pure nitrogen. Average surface conductivity of the scanned area was gradually decreasing over time in both cases, faster in air. This was explained by oxygen out-diffusion in both cases and chemical reactions with water vapor in air. The obtained surface conductivity images also revealed its high inhomogeneity on micrometer and nanometer scale with numerous regions of highly enhanced conductivity compared to the surroundings. Furthermore, it has been shown that the size of these conductive regions considerably depends on the applied voltage. We propose that such inhomogeneous surface conductivity is most likely caused by varying thickness of degrad

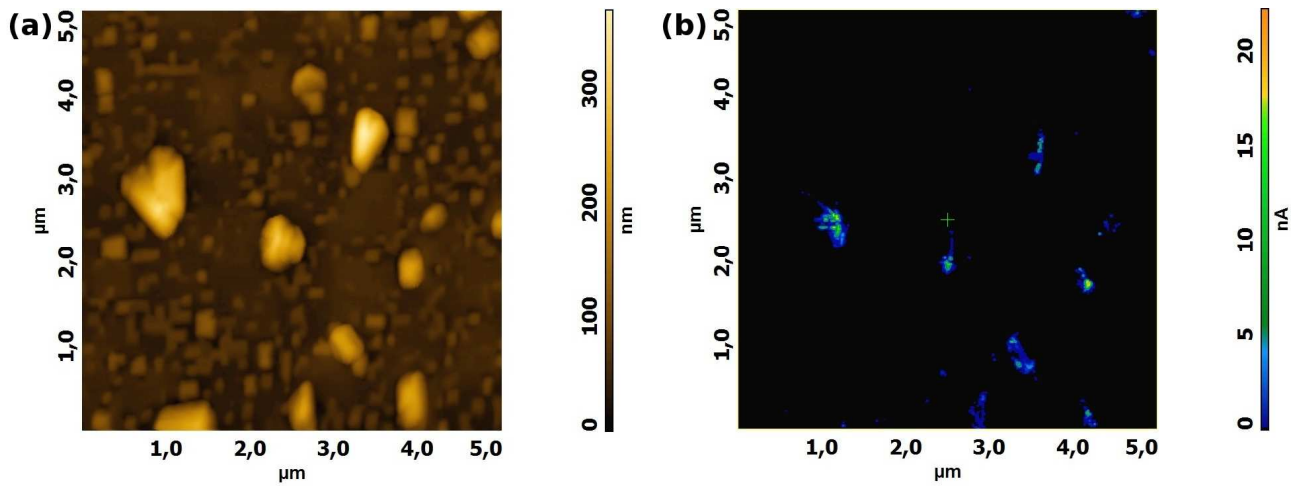
Fig. 1. (Color online) Typical (a) AFM topography and (b) SSRM image (bias voltage 1.5 V) of the YBCO surface stored in air for several days before the ion beam etching.

Typical AFM topography and corresponding SSRM images (1.5 V bias voltage) of the YBCO films stored on air for several days are shown on Fig. 1. The SSRM image clearly shows that the YBCO surface conductivity is very low due to highly degraded (the x parameter is close to zero) near-surface layer and some current flows only through areas of the highest surface irregularities.

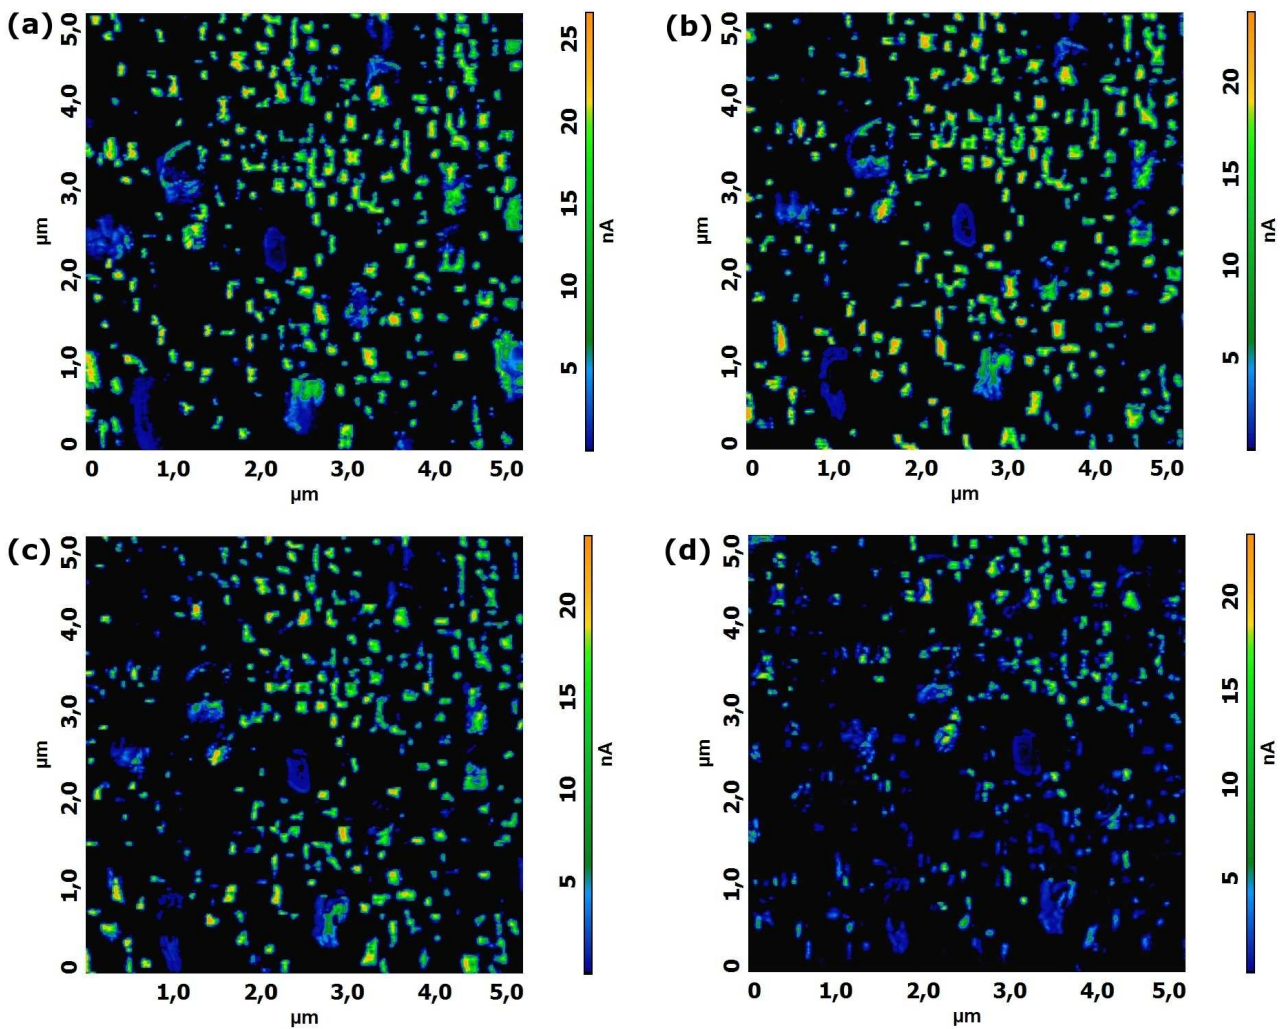
Fig. 2. (Color online) SSRM images (bias voltage 1.5 V) of the YBCO surface after (a) 1.5 hours (b) 4 hours (c) 7 hours (d) 9 hours in air after the sample was etched in ion beam. Bright areas indicate regions with high conductivity.

After the degraded layer has been removed by the ion beam etching, the average surface conductivity considerably increased although the current distribution over the sample surface was highly inhomogeneous (Fig. 2a). For the degradation studies, the samples were stored in air or pure nitrogen atmosphere and selected area of $5 \times 5 \mu\text{m}$ has been repeatedly scanned by the SSRM over several hours after the ion beam etching and the current / conductivity map has been recorded for each scan (Fig. 2). The SSRM images clearly show that the average conductivity of the cleaned YBCO surface gradually decreases in time in both air and pure nitrogen atmosphere. The time dependence of the average current density calculated from the SSRM images (Fig. 3) shows its approximately linear decrease in time over first 8 hours after the initial degraded layer was removed by the ion beam etching. The degradation was slightly slower in nitrogen atmosphere due to lack of water vapor which causes additional degradation of the YBCO surface due to various chemical reactions [9]. However, the surface still undergoes degradation due to oxygen out-diffusion which, as was pointed above, is suppressed only at low temperatures.

The observed decrease of the surface conductivity over time is in agreement also with works done on YBCO/metal contacts [5]. Effects shown in Fig. 2 and 3 show that the shape of I-V and dI/dV -V characteristics measured on typical μm -sized junctions can change in time, particularly within the first several hours after the preparation of the junction.

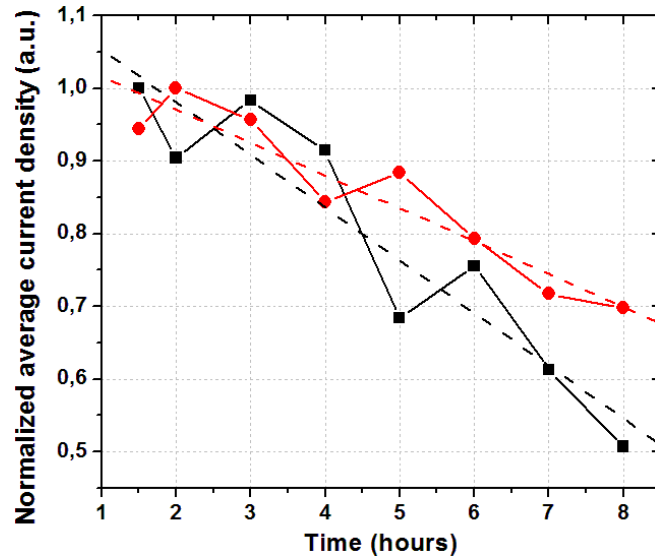
Fig. 3. (Color online) Average SSRM current (normalized to maximum value) measured on YBCO surfaces stored in air (black squares) and pure nitrogen (red circles) after the ion beam etching calculated from the $5 \times 5 \mu\text{m}$ SSRM images as a function of time. The linear fits (dashed lines) are a guide for an eye.

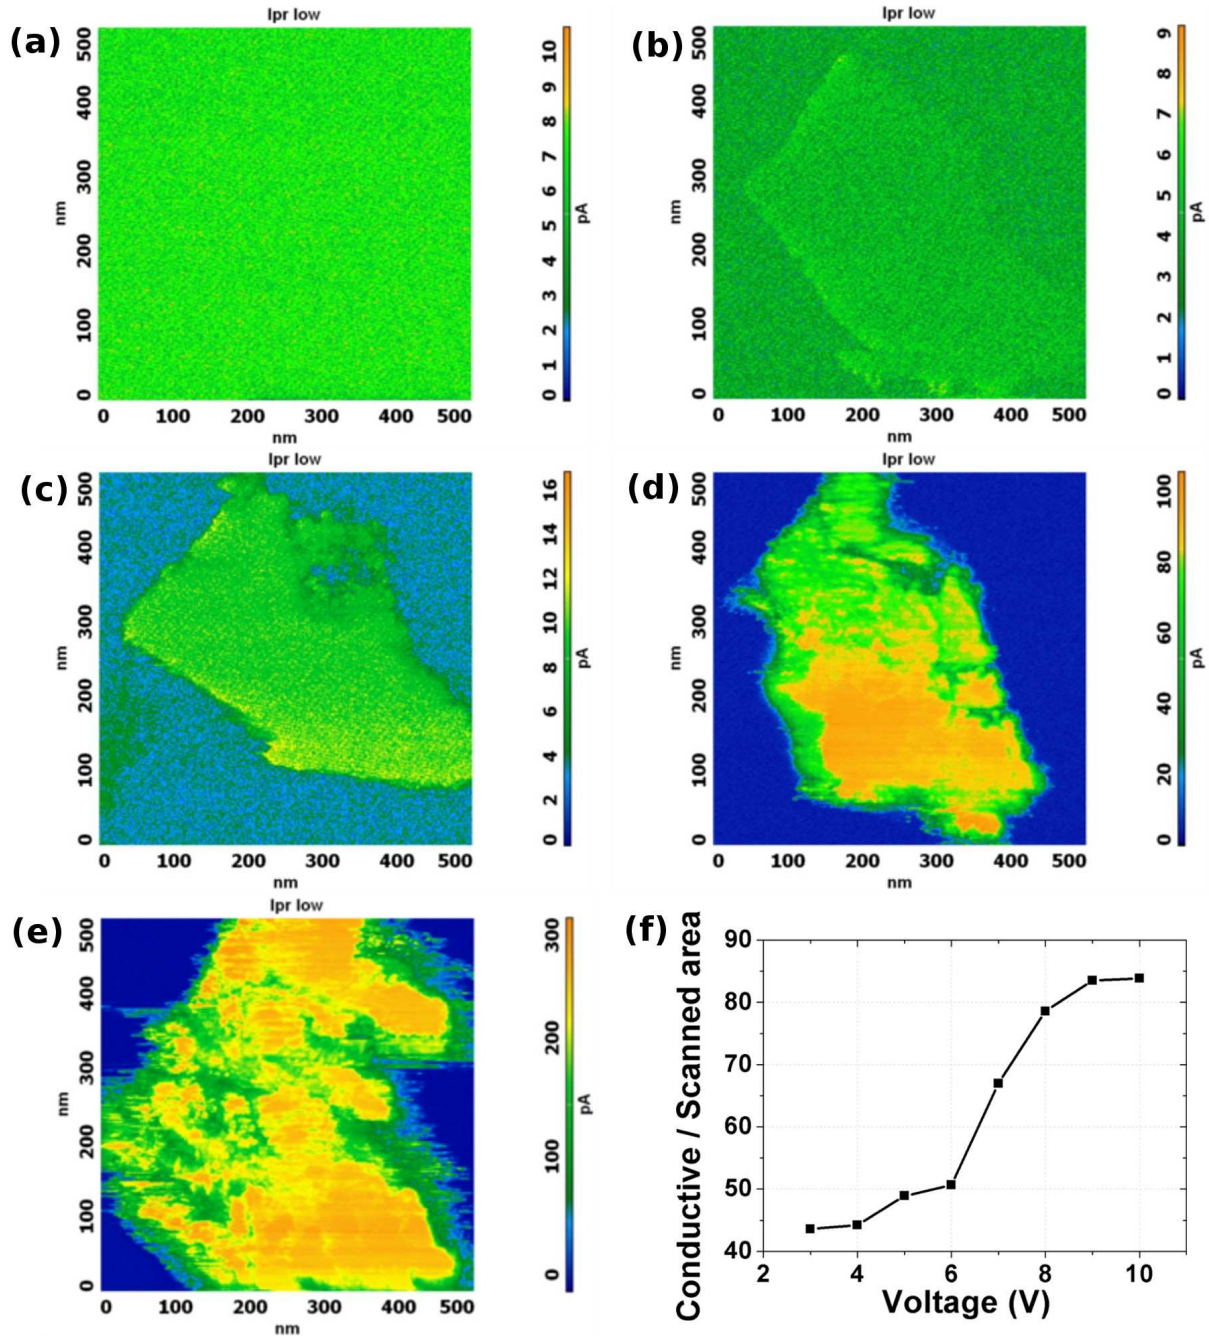
Fig. 4. (Color online) SSRM images of a selected region with one of the high-conductivity areas on YBCO surface at voltages (a) 1 V; (b) 2 V; (c) 4 V; (d) 6 V; (e) 8 V. (f) Size of the high-conductivity area normalized to the scanned area as a function of the applied voltage.

Subsequently, we have focused on a selected surface region with one of the areas with higher conductivity, which generally had an irregular shape. In general, their conductivity, shape and size considerably varied with applied voltage (Fig. 4). At bias voltage of +1V, the high-conductivity area was practically not visible on the SSRM image and its conductivity appeared to be the same as the surroundings (Fig. 4a). With increasing voltage to +2V, its conductivity became higher compared to surroundings and it became visible (Fig. 4b). With further increasing of the applied voltage, both the conductivity and size of this high-conductivity area were gradually increasing (Fig. 4c-f). Conversely, conductivity of the surrounding surface remained very low and practically immeasurable.

Existence and behavior of such areas can be explained by varying thickness of the degraded insulating surface layer. These variations are most likely given by the polycrystalline nature of the film, where near-optimally doped grains of various shape and size may be present under the insulating layer. Depending on their size, shape and placement, the thickness of the degraded insulating barrier can vary from zero (direct contact) through very thin (~ 1 nm) where the transport properties are given by a tunneling current, up to relatively thick (several nanometers) completely insulating barrier. As the oxygen diffusion is expected to be faster along the crystalline boundaries, we propose that the polycrystalline nature of the film most likely does not lead only to variable thickness of the degraded layer, but also to inhomogeneous oxygen distribution (x-parameter) in the CuO chains of the YBCO unit cells within the surface degraded layer itself. This, according to the YBCO T-x phase diagram may also have significant effect on the surface conductivity. To support these propositions the YBCO films were examined in cross-section by SEM to confirm their polycrystalline nature (Fig. 5a). Furthermore the surface of the films was analyzed by AES and SAM after in-situ cleaning by ion-beam etching (800 eV ion energy) in UHV chamber. The AES spectra (Fig. 5b) did not show any surface contamination (e.g. carbon) which might have led to variation of oxygen concentration on the surface. However, inhomogeneous oxygen distribution on micrometer scale has been confirmed by SAM by mapping intensity of the oxygen Auger peak over the sample surface (Fig. 5c).
