# Graphenic Carbon-Silicon Contacts for Reliability Improvement of Metal-Silicon Junctions

**Abstract** – Contact resistance and thermal degradation of metal-silicon contacts are challenges in nanoscale CMOS as well as in power device applications. Titanium silicide (TiSi) contacts are commonly used metal-silicon contacts, but are known to diffuse into the active region under high current stress. In this paper we show that a graphenic carbon (C) contact deposited on n-type silicon (C-Si) by CVD, has the same low Schottky barrier height of 0.45 eV as TiSi, but a much improved reliability against high current stress. The C-Si contact is over  $10^8$  times more stable against high current stress pulses than the conventionally used TiSi junction. The C-Si contact properties even show promise to establish an ultra-low, high temperature stable contact resistance. The finding has important consequences for the enhancement of reliability in power devices as well as in Schottky-diodes and electrical contacts to silicon in general.

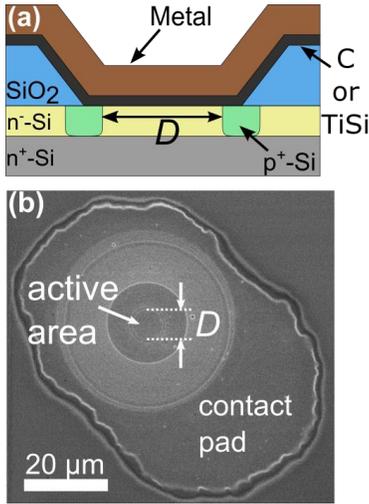
Fig. 1. (a) shows a schematic cross-section of the used Schottky diode with guard ring and C or TiSi at the interface. The SEM image in (b) shows the top view of a C-Si diode with top contact deposited through a shadow mask. The diameter  $D$  of the active region is  $7.6 \mu\text{m}$ .

A Schottky diode structure, as shown in Fig.1 is used in this work to compare the characteristics and reliability of a TiSi-based diode (commercial BAT15 diode from Infineon) with a C-Si Schottky diode, where the “metallic contact” to the silicon is established by graphenic carbon (C) deposited by CVD [7,8]. The same silicon vehicle with all dimensions, dopants and guard rings like the commercial BAT15 was provided by the manufacturer and was used in the experiment to allow for a direct comparison. Due to the small thickness of 150 nm of the n-epitaxial layer, the BAT15 vehicle is very susceptible to degradation in its electrical reverse-bias characteristics when contaminations like metal ions enter the epitaxial region, like shown in Fig. 2(a). By studying the reverse characteristic of the Schottky diode at -1V reverse bias after the application of a short, 100 ns long, high current pulse,

C-Si diodes were fabricated by CVD-deposition of graphenic carbon onto the cleaned Si-surface of the BAT15 structure at temperatures between 800°C and 1000°C [7,8]. The layered structure of the carbon layer is nicely seen in the cross-section shown in Fig. 4(b). The cleaved sample reveals the high anisotropy of the carbon growth. Consequently, the graphenic carbon has an in-plane resistivity of 1 m $\Omega$ ·cm and in the direction perpendicular to the surface a resistivity of 50 m $\Omega$ ·cm. This value is extracted from analyzing samples with varying carbon thickness and fitting to the obtained data plotted in Fig. 4(a). The graphenic carbon film is structured by depositing a metal stack consisting of 50 nm Ti, 1.3  $\mu$ m Cu and 40 nm Au through a shadow mask on to the carbon. Subsequently the carbon was etched away in a hydrogen plasma with the metal stack acting as a hard mask (Fig. 1(b)).

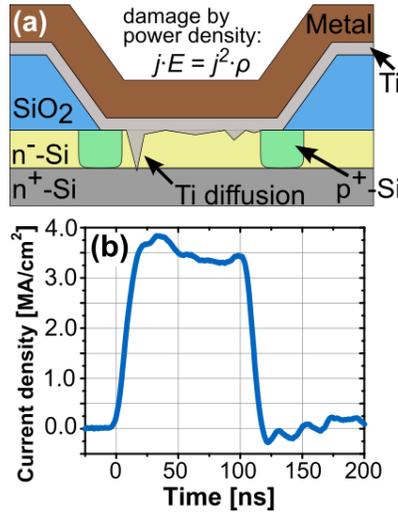
Fig. 2. (a) shows a schematic cross-section of a TiSi Schottky diode with guard ring structure where Ti diffuses into n-Si by the application of a high current pulse. Image (b) shows a typical waveform of a 100 ns current pulse with a rise/fall time of  $\sim 15$  ns.

Commercially available BAT15 Schottky diodes with TiSi contacts were pulsed with different current densities and the pulse number dependent reliability results are plotted in Fig. 3. The current pulse with duty cycle smaller than 0.0001 has a length of 100 ns and a rise/fall time of about 15 ns, like shown in Fig. 2(b). If the reverse current reaches a value of 100  $\mu$ A at -1 V, the on/off ratio of the diode is deteriorated by a factor of 100 and the diode is declared as failed. From Fig.3 it is observable that the maximum number of transient stress pulses depends on the used current density level. For 1.35 MA/cm<sup>2</sup>, which is slightly above the permissible pulse load of 1.21 MA/cm<sup>2</sup>, specified by the manufacturer, the diode is able to withstand up to  $10^6$  events but the failure probability is spread over a wide range. Moving to higher current densities increases the probability for damage severely and **the TiSi junction can only withstand 2-4 pulses at 3.5 MA/cm<sup>2</sup>.**

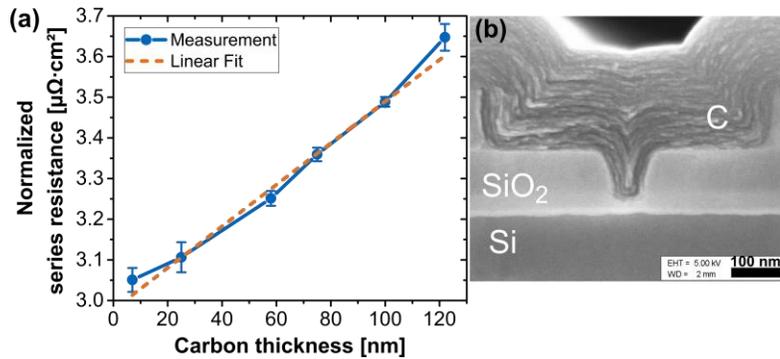
Fig. 4. The area-normalized series resistance of the C-Si Schottky diode as a function of the graphenic carbon thickness on the diode with the same metallization layers on top is shown in (a). The out-of-plane electrical resistivity is extracted to be  $50 \text{ m}\Omega\cdot\text{cm}$ . The laminar growth of graphenic carbon is revealed in the cross-section SEM in (b) of a cleaved sample, which displays the graphenic carbon layers. Due to the anisotropy, the resistivity in the perpendicular direction is 50x of the in plane value which is  $1 \text{ m}\Omega\cdot\text{cm}$ .

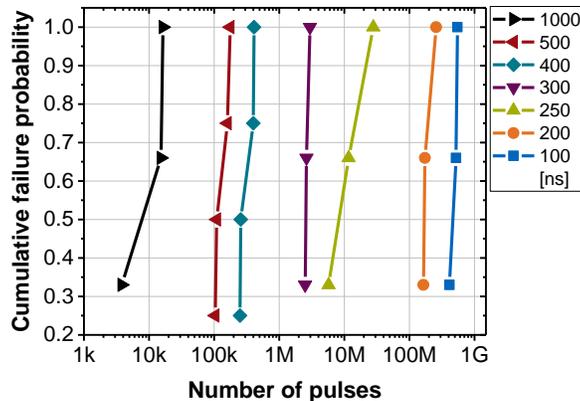
Fig. 6. Failure probability is plotted as a function of the number of pulses at different pulse lengths for the C-Si Schottky diodes. At least three devices were stressed with a given pulse current density of  $3.5 \text{ MA/cm}^2$  and a duty cycle  $< 0.0005$ . The failure of the diode was defined when the diode degrades to a reverse current  $> 100 \mu\text{A}$  @  $1 \text{ V}$ .

A graphenic carbon thickness of 28 nm was used to evaluate the impact of different current pulse lengths and fixed amplitude. The results are plotted in Fig. 6. The diodes can withstand up to 548 million pulses with a width of 100 ns before they fail. The failure probability is getting higher at a lower total number of pulses by increasing the pulse length. But the C-Si diodes still can withstand up to 16,000 pulses with a current pulse length of 1  $\mu$ s which is still much more than the BAT15 can endure at a pulse width of 100 ns. Fig. 7 compares the failure probability of the TiSi BAT15 and the C-Si diode and clearly illustrates that graphenic carbon can **enhance the robustness against high current events (like ESD) by a factor of over 100 million.**

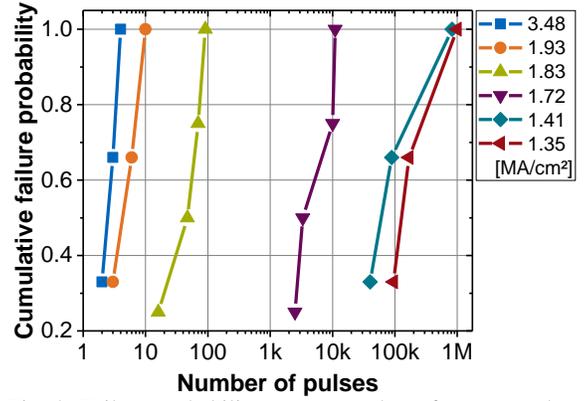
Fig. 3. Failure probability versus number of current pulses at different current densities for commercial BAT15 diodes with TiSi interface. At least three devices were stressed for a given pulse current density, a pulse width of 100 ns and a duty cycle  $< 0.0001$ . The failure of the diode was defined when the diode degrades to a reverse current  $> 100 \mu\text{A}$  @  $1 \text{ V}$ . The minimum current level is above the permissible pulse load of  $1.21 \text{ MA/cm}^2$  specified by the manufacturer.

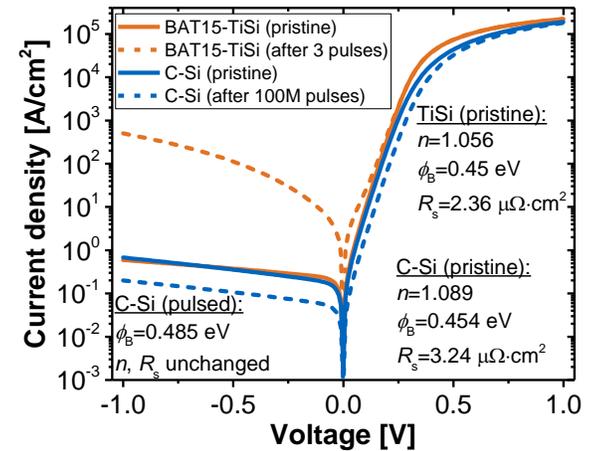
Fig. 5. Comparison of the dc characteristics of the BAT15 (TiSi) and the C-Si diode with a carbon thickness of 58 nm. Ideality factor  $n$ , Schottky barrier height  $\Phi_B$ , and area-normalized series resistance  $R_s$  are displayed for the pristine BAT15 and C-Si diode. The barrier height is almost equal for both devices. After current pulses with a current density of  $3.5 \text{ MA/cm}^2$ , the TiSi shows a strong degradation in the reverse characteristics after 3 pulses while the C-Si diode has even a lower reverse current and is still fully functional after 100 million pulses.

The dc-characteristic of the pristine (no current pulse yet applied) TiSi and C-Si diodes with a carbon thickness of 58 nm are compared in Fig. 5. The substrate of the C-Si is not back-thinned like in the commercial TiSi-diode and therefore the C-Si diode has a little higher resistance. The ideality

factors  $n$  and the Schottky barrier heights (SBH)  $\Phi_B$  of the two diodes are almost the same. Fig. 5 also displays the dc-characteristics after three current pulses for the TiSi-diode and after 100 million pulses for the C-Si diode with a pulse strength of 3.5 MA/cm<sup>2</sup>. After three pulses the TiSi diode is destroyed as evidenced by the high reverse current. In contrast to this, the C-Si diode survives at least 100 million equivalent current pulses. After 100 million pulses the reverse current is reduced by a factor of 4 and the Schottky barrier height  $\Phi_B$  increased. This might be due to the formation of a very thin SiC-layer at the C-Si interface.

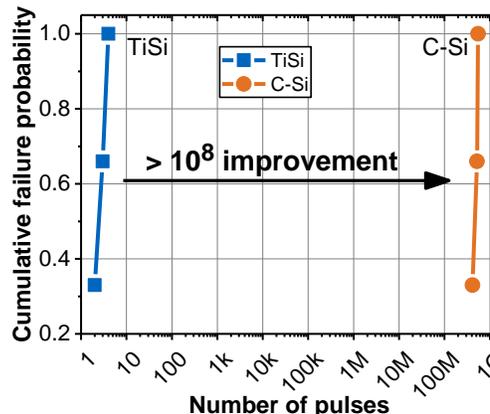
Fig. 7. Comparison of stress pulse endurance of TiSi and C-Si diodes for a current density of  $3.5 \text{ MA/cm}^2$  and a pulse width of 100 ns. The majority of TiSi (BAT15) diodes is deteriorated after 3 pulses whereas the C-Si diodes can withstand **over  $10^8$  more pulses** until a wear out is observed. This direct comparison underlines the importance of the C-Si contact scheme.

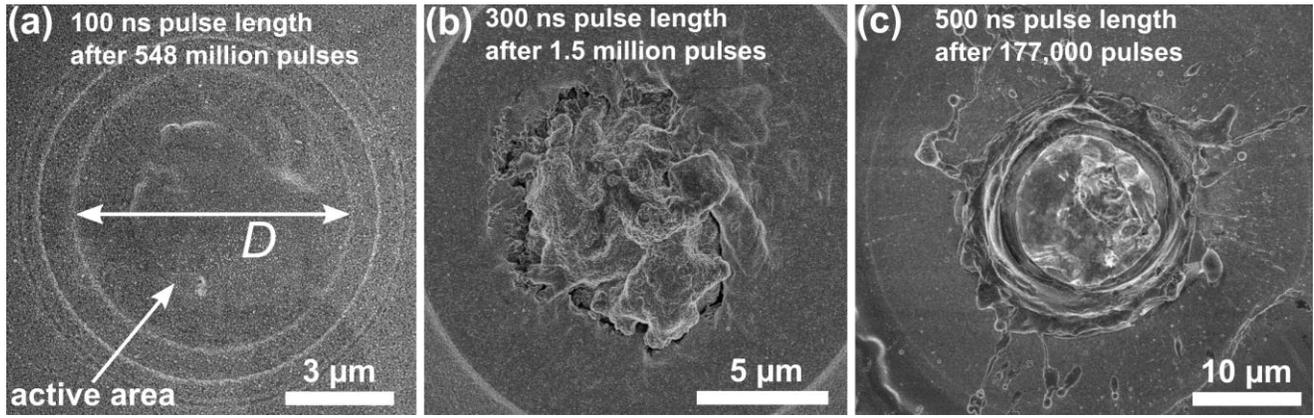
Fig. 8. SEM image of the top view of carbon-silicon Schottky diodes with copper as top metallization. All the devices were stressed with the same current level of  $3.5 \text{ MA/cm}^2$  while only the pulse length was altered. The images were recorded after the diodes failed. (a) shows a device after 548 million pulses of a length of 100 ns where almost no damage in the top metallization is visible. The device in (b) demonstrates the damage of a 300 ns pulse after 1.5 million pulses where the metal even started to melt and to pile up. (c) illustrates a sample where the current-induced damage of a 500 ns pulse melted the metal so far that it spilt on the periphery but the device could even withstand 177,000 pulses.

The top metallization of the diode was analyzed by a scanning electron microscope (SEM) to examine how much the surrounding area of the active device region is damaged by the current pulses (Fig. 8). For a 100 ns pulse, the damage to the top metallization is hardly visible as the event is so short that heat can hardly spread away from the active area (Fig. 8(a)). The visible bump here may just arise due to the thermomechanical stress by thermal expansion at each cycle. In Fig. 8(b-c) the top metallization is heated to the point that it is even melted and caused a pile-up of the metal. The copper starts to spit out molten metal on the periphery of the diode at a pulse width of 500 ns. Fig. 9 reveals that the failed diodes are not open devices, but have been shortened, most probably by a diffusion of the dopants. Si-C diodes with 28 nm and 58 nm carbon thickness were tested at even higher current levels. For the diode with a 58 nm thick carbon film, a maximum applicable current density of 9.3 MA/cm<sup>2</sup> could be identified. Like shown in Fig. 10, the first pulse is not destructive to the device. Only a slightly higher reverse current is observable but the acceptable breakdown voltage (100  $\mu$ A @  $V_r=4$  V), as specified for the BAT15, is still fulfilled. Only the second pulse is destructive to the diode and it completely fails. For the sample with the 28 nm thick carbon a maximum manageable current strength for a single pulse was identified to be 8.0 MA/cm<sup>2</sup>. The reason of the deterioration could not yet be revealed. It could be redistribution and diffusion of dopants due to the induced temperature and/or diffusion of Ti through the carbon layer towards the interface.

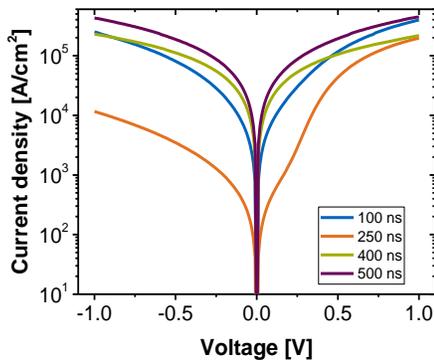
Fig. 9.  $J(V)$ -characteristics of C-Si diodes after they reached the threshold for a failed diode during the test in Fig. 6. The diodes show an increased  $J_0$  and consequently a reduced Schottky barrier height.

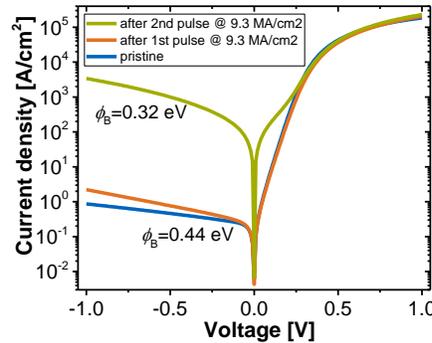
Fig. 10.  $J(V)$ -characteristics of a C-Si diode with a carbon thickness of 58 nm. After one pulse with a current density of  $9.3 \text{ MA/cm}^2$  the diode is fully functional and its reverse behavior still close to the pristine curve. Only the second pulse is destructive.

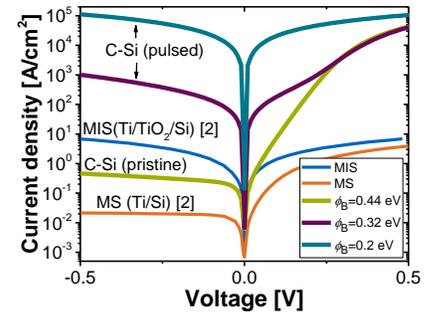
Fig. 11. Comparison of current density plots  $J(V)$  of literature values of MS (Ti/Si) and MIS (Ti/TiO<sub>2</sub>/Si) with C-Si values. The contact resistance  $\rho_c$  is inversely proportional to  $J_0$  which is even higher for pristine C-Si compared to the MS diode from [2]. The pulse-annealed C-Si diodes are even much better.

temperatures [2,3]. The value of the saturation current density  $J_0$  of a contact is a good indication for the SBH and the obtainable  $\rho_c$ . Fig. 11 compares current density plots of C-Si with recent efforts from Hu et al. to achieve low  $\rho_c$ . **Pulse-annealed C-Si contacts clearly outperform recent efforts to achieve record low  $\rho_c$  and even pristine C-Si contacts are within an attractive range.**

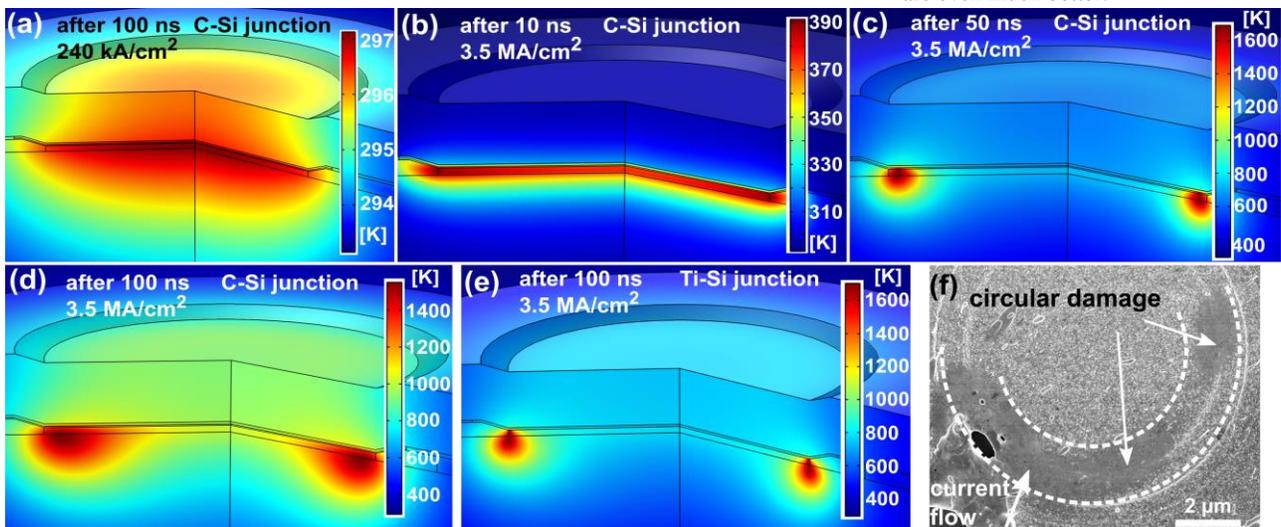
Fig. 12. Time-dependent electro-thermal simulations of the used Schottky-contacts. Image (a) shows the temperature in the device operated at normal conditions ( $240 \text{ kA/cm}^2$ ). In (b)-(d), the temperature distribution in C-Si diode is shown when stressed with a  $3.5 \text{ MA/cm}^2$  current pulse. A circumferential hot-spot is created in the epi-layer during the pulse, but the heat spreads out which cools down the hot spot under the melting temperature. This is due to the unusual temperature dependent electrical resistivity which has a minimum at around 900 K and increases again at higher temperature. In (e) titanium (Ti) is used as interface metal. Here, the hot spot doesn't disappear during the pulse which can lead to a more severe damage to the device. The SEM image in (f) shows a C-Si diode with thinner metallization after several  $3.5 \text{ MA/cm}^2$  pulses. The direct current path from the probe tip to the diode is indicated by the arrow. A recrystallization of the top metallization at the transition region between guard ring and active epi region occurs. This indicates that the main damage is indeed created in a circular fashion around the diode active area, like identified in the FEM simulations.

To get a deeper insight to the heat distribution in the diode during the ESD event, coupled time-dependent electro-thermal simulation based on finite element method (FEM) were performed. Temperature dependent parameters were used for all materials. The experimentally measured current waveform and density was used in the simulations. The temperature distribution in the C-Si diode near the active region is shown in Fig. 12(a-d) for different time steps. At low current densities the diode keeps cool and close to room temperature. At high current densities a circumferential hot spot is created around the active area close to the guard ring structure which is guided by current crowding. The temperature even rises to the melting point of silicon (Fig. 12(c)) but due to the *unusual temperature dependent electrical resistivity of carbon (which has a minimum at ~900 K)*, not enough current can be provided to keep the hot spot at high temperature. The heat in the device can spread to the periphery which reduces the maximum temperature. When the same layout is used with Ti at the interface, the hot spot doesn't disappear which confirms a higher damage potential of the sample without carbon (Fig. 12(e)). This edge behavior has been verified in the real C-Si diode by stressing the diode with a thinner top metallization. Fig. 12(f) illustrates that a recrystallization of the Cu occurs at the transition region between active and guard ring area occurs, which points to a higher temperature in this edge region and confirms the simulated results.
