Development of an Experimental Setup to Analyze Carbon/Epoxy Composite Subjected to Current Impulses

P. GHARGHABI, J. LEE, M. S. MAZZOLA and T. E. LACY

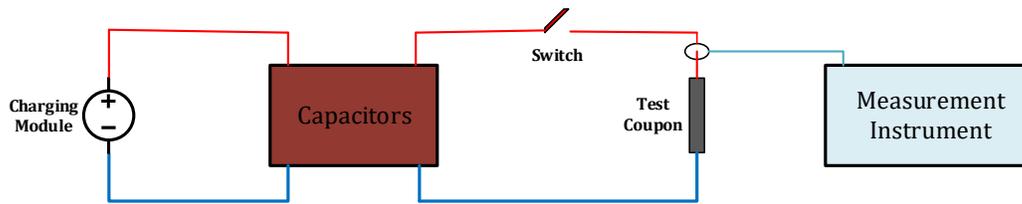
To perform current impulse tests on composite coupons a system was designed which is capable of producing current impulses up to 300 A peak amplitude in the range of microseconds. The schematic of the system is shown in Figure 1.

Figure 1. Schematic of current impulse test setup

The test setup consists of a charging module, capacitors for energy storage, a test coupon, electrical contacts, and a measurement instrument. The charging module is a DC source that can provide voltages up to 1 kV, and it feeds the capacitors through a gate driver up to the target voltage. The capacitor bank consists of four 100 μF capacitors, and they are connected in parallel to ensure that maximum current can be derived from this setup. An enabling component of the impulse generator is a 1200 V SiC JFET multi-chip transistor module. This module can safely switch impulse currents greater than 1 kA at a di/dt in excess of the wave shape requirements for this study. High di/dt switching of the module is enabled by a proprietary gate drive circuit designed specifically for SiC JFET modules.

The current impulse was measured using a clamp current measuring device, which is a current transformer with wire coil as one winding and conductor as the other winding. The output of the clamp is connected to a 1 GHz digital oscilloscope, which captures and records the current wave shape. By triggering the gate driver, the energy stored in the capacitor bank is discharged to the load. The higher the charging voltage, the larger the output current will be. Therefore, by controlling the input voltage the discharged current impulse can be changed to the target value. This fact is based on the valid assumption that all the electrical parameters of the circuit remain constant. The impulse current wave form recorded at charging voltage of 300 V applied on the unidirectional coupon sample 1 is shown in Figure 2. Different current impulse parameters can be measured from the waveform. The peak amplitude of the current impulse is measured to be 284 A, and rise time of the waveform, which is defined from zero to peak amplitude, is measured to be 4.68 μs . The tail time, from the peak amplitude to half of the peak value on the tail of the waveform, is 17.6 μs .

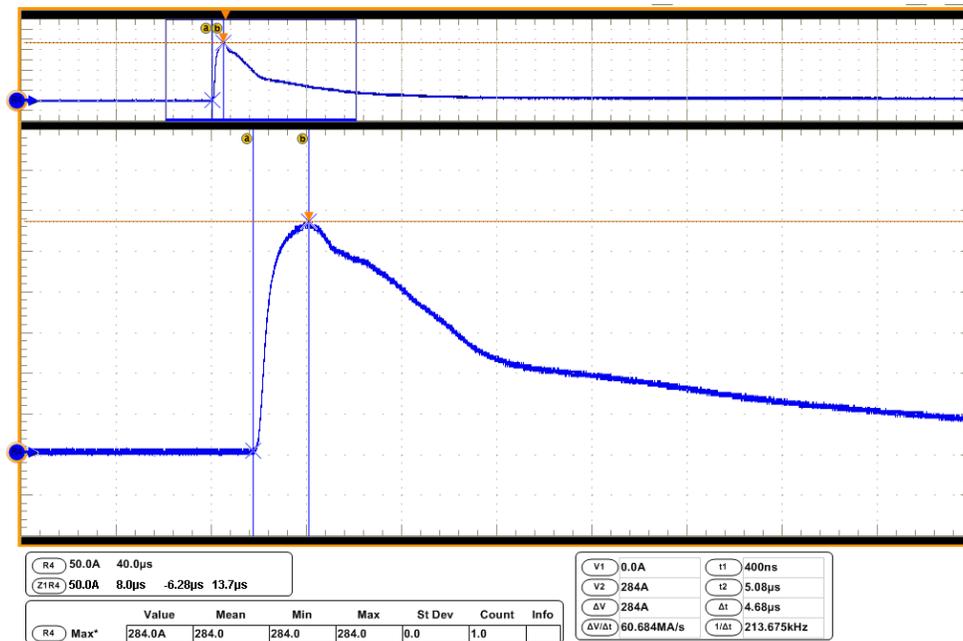
Figure 2. Electric current vs time, unidirectional coupon, sample 1, peak amplitude 284 A front time 4.68 µs, tail time 17.6 µs

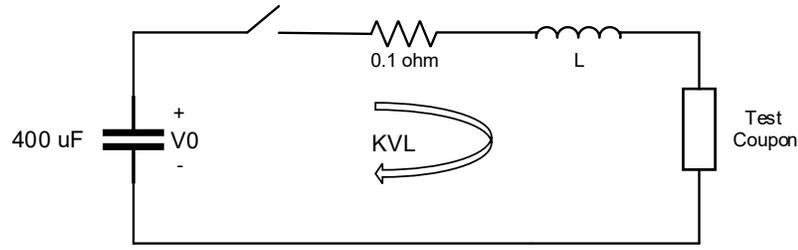
The impulse current generator can be represented by a series RLC circuit to study its response and output specifications. The equivalent electrical circuit is shown in Figure 3 and all three components are in series. C represents the equivalent capacitance

Figure 3: Series RLC circuit representing the current generator

in the circuit, since four capacitors are connected in parallel and the equivalent capacitance would be 400 μF . L represents the self inductance in the circuit caused by loop of wires or straight wires and connections, and V_0 is the DC charging voltage supplied by the charging unit. Using Kirchhoff's voltage law, the governing differential equation can be written as

$$\begin{aligned} \frac{1}{C} \int i dt + L \frac{di}{dt} + Ri = V_0 \\ \frac{d^2i}{dt^2} + \frac{R}{L} \frac{di}{dt} + \frac{1}{LC} i = 0, i(0^+) = 0, \frac{di(0^+)}{dt} = V_0 / L \end{aligned} \quad (1)$$

$$\frac{d^2i}{dt^2} + 2\alpha \frac{di}{dt} + \omega_0^2 i = 0 \rightarrow \alpha = \frac{R}{2L}, \omega_0 = \frac{1}{\sqrt{LC}}, \zeta = \frac{\alpha}{\omega_0} = \frac{R}{2} \sqrt{\frac{C}{L}} \quad (2)$$

The first return stroke of lightning current is approximated by a double exponential wave shape. To have the overdamped case (i.e., double exponential waveform), ζ should be greater than 1. In this case, the two poles are real and unequal on the left half side of S plane. The solution of the equation may be found as

$$s_{1,2} = \left(\zeta \pm \sqrt{\zeta^2 - 1} \right) \omega_0, i(t) = A \left(e^{-s_1 t} - e^{-s_2 t} \right) \quad (3)$$

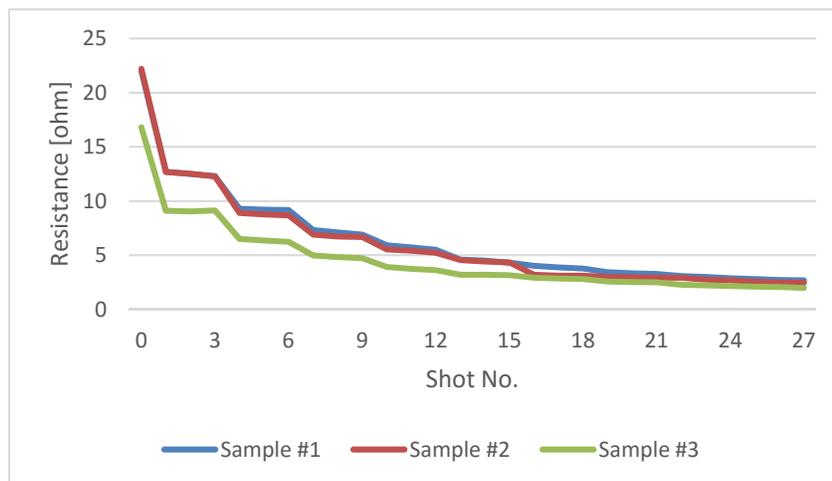
The change of electrical resistance of the unidirectional and cross ply coupons are shown in Figure 4 and Figure 5. The trend of the change of electrical resistance against the cumulative number of current impulses shows that successive current impulses changes the resistance of the coupons. Similar phenomenon was also reported in [13], and it was concluded that electrical resistance decreases with increase in the applied current magnitude. The decrease of the resistance is indicative of internal change in the carbon composite which is irreversible.

Figure 4. Resistance measurements of current impulse test, Cross ply coupons, sample No. 1, 2 and 3

Because the unidirectional coupons have lower resistance, they reach higher discharge currents at lower voltages. Thus, cross ply coupons need higher voltage to reach current limit. The resistance of both samples decreases as the magnitude of current impulse increases. They reach almost half of initial value of resistance at roughly around 10 A of discharged current, which is a relatively low current compared to actual lightning impulse. To explain the relevance of this testing in that context, we consider a coupon is a small patch of a much larger portion of the aircraft structure that is carrying lightning impulse current in a zone away from the attachment point; which makes the current levels used in this study relevant.

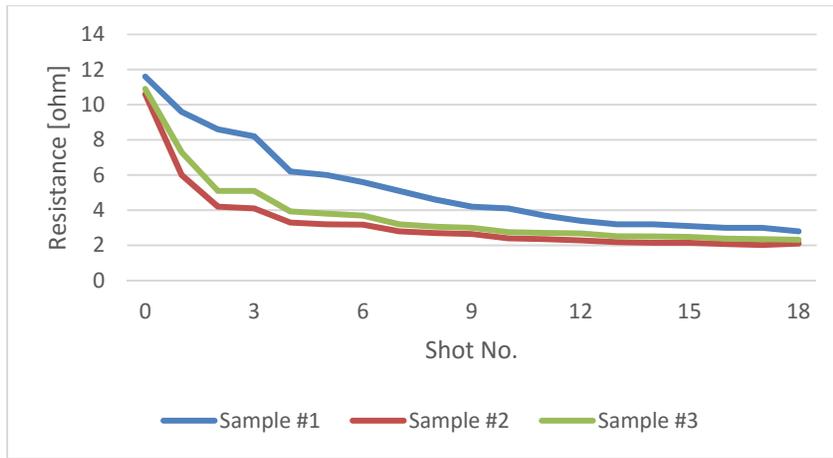
Figure 5: Resistance measurements of current impulse test, Unidirectional coupons, sample No. 1, 2 and 3

Before any application of current impulses to the specimens, the average value of electrical resistance of three cross ply laminates is 20.26 Ω , while that of unidirectional laminates is 11.03 Ω . As demonstrated in Figure 5, the resistance decreases considerably during the first few current impulse applications. After this significant drop, the resistance change lessens, and tends to be linear at higher current impulses. This trend, at higher current magnitudes, might imply that the path for the current flow is formed inside the coupons. Another result that can be deduced from Figure 5 is that cross ply coupons experience more resistance change compared to unidirectional coupons. In a cross ply coupon, discontinuity of different electrical and mechanical properties at the interface between carbon fiber and epoxy matrix is more pronounced. Therefore, the effects of current crossing laminate boundaries are more accentuated, and the effect of the weak zones on the resistance change inside coupons is greater in cross ply coupons as compared to unidirectional coupons.

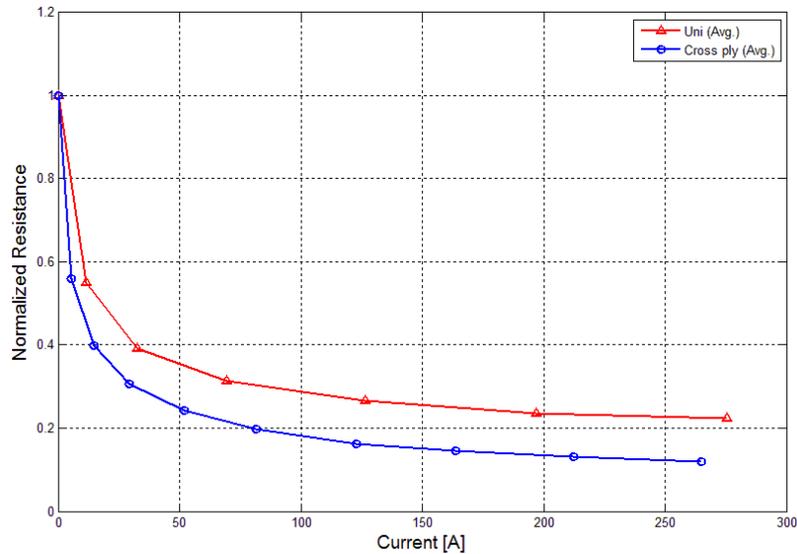
To be able to compare measurements of two unidirectional and cross ply coupons, the values and measurements should be normalized or adjusted to a common scale. The average resistances of three coupons at each level of charging voltage is divided by the average resistance before any impulse application. Therefore, all readings are between 0 and 1, which shows normalized resistance change. The diagram of normalized resistance change against magnitude of current impulse is presented in Figure 6.

Fig. 6: Normalized electrical resistance vs current discharge magnitude, Cross-ply and unidirectional coupons
